**PRIMARY RECORD**

Page 1 of 6 \*Resource Name or #: (Assigned by recorder) Odd Fellows Hall

P1. Other Identifier: Brandt Building

\*P11. Report Citation: Section 106 Evaluation of the Brandt Building for Collocation of Wireless Antennas, 250 Healdsburg Avenue, Healdsburg, Sonoma County, CA, Assessor Parcel 002-242-008, Site #SF-438-02

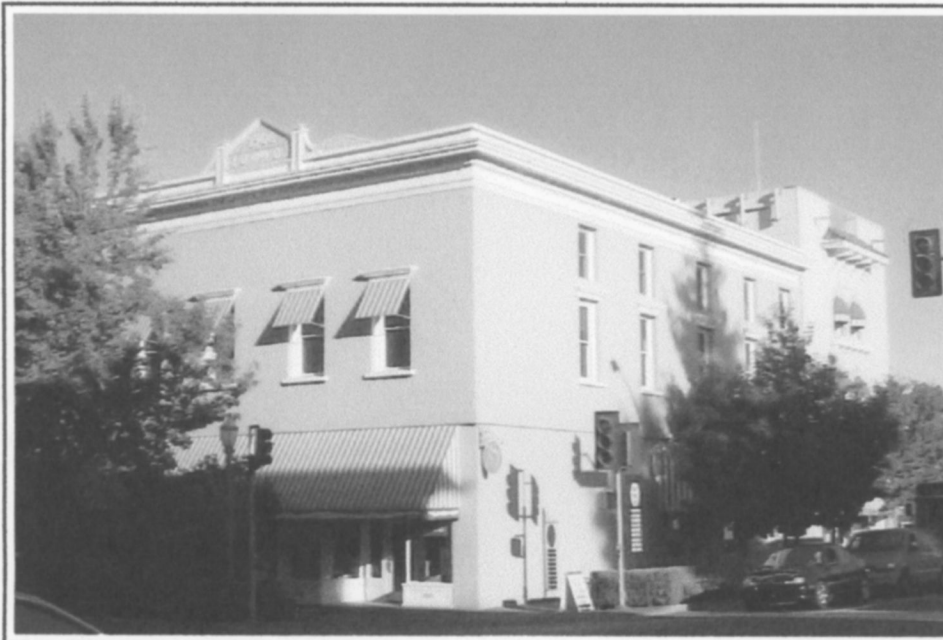
The Brandt building is located on the southeast corner of a busy intersection in Healdsburg's downtown commercial district. The three-storey brick and stucco building was constructed as an I.O.O.F. Lodge and commercial building in 1905. The rectangular parcel measures 104.69 feet by 45.14 feet. The 50-foot tall building fills the parcel. The building is composed of two sections, built one year apart by the same contractors, using differing styles and materials. The south volume of the building, 250 Healdsburg Avenue, was constructed in 1905. It survived the 1906 Earthquake. The north portion of the building, 102 Healdsburg Avenue, was built in 1906 to replace the original north section which collapsed in the 1906 Earthquake. (See Continuation sheet)

\*P5b. Description of Photo: (view, date, accession #) North and west elevations: July 2002 photo
