HISTORIC RESOURCES INVENTORY

- 1. Common name: Abshire House
- 2. Historic name: Abshire House
- 3. Street or rural address: 1956 Highway 128
City Geyserville, CA Zip 95441 County Sonoma
- 4. Parcel number: 140-250-04
- 5. Present Owner: Michalek, Katherine & Jesse E. Address: 1956 Highway 128
City Geyserville, CA Zip 95441 Ownership is: Public _____ Private X
- 6. Present Use: Residential Original use: Residential

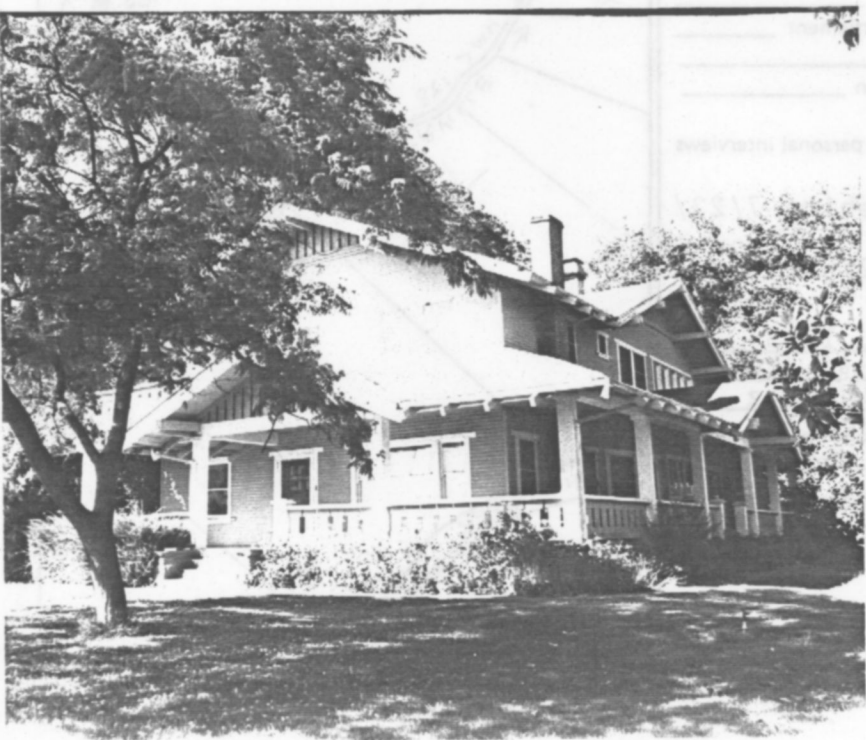
A very large, two-story house with crossed gables and exposed rafter tails. The barge rafters rest on extensions of the roof beams. An expansive hip roof porch wraps the front and side with gables over the steps. Many of the double-hung windows are in groups of two or more. The frames are plain with extended lintels. There is a slanted bay on the veranda side of the house. Gables on the main structure and on the veranda have vents and the balustrade is made up of flat "I" shape balusters. The columns are square with small square capitals. Covering the entire structure is narrow lap rustic siding.

13. Condition: Excellent ___ Good X Fair ___ Deteriorated ___ No longer in existence ___
14. Alterations: None visible
15. Surroundings: (Check more than one if necessary) Open land X Scattered buildings ___ Densely built-up ___
Residential ___ Industrial ___ Commercial ___ Other: _____
16. Threats to site: None known X Private development ___ Zoning ___ Vandalism ___
Public Works project ___ Other: _____
17. Is the structure: On its original site? X Moved? ___ Unknown? ___
18. Related features: Set near Highway 128 is a landscaped garden.

This residence is an unusually large example of the Craftsman style. It has typical Craftsman features such as wide gables and exposed rafter tails.
