HISTORIC RESOURCES INVENTORY

1. Common name: \_\_\_\_\_
2. Historic name: James Patrick House
3. Street or rural address: 6738 State Highway 128  
City Healdsburg, CA Zip 95448 County Sonoma
4. Parcel number: 131-170-26-8
5. Present Owner: Goodyear, Robert & Caroline Address: 6736 State Hwy. 128  
City Healdsburg, CA Zip 95448 Ownership is: Public \_\_\_\_\_ Private X
6. Present Use: Residential Original use: Residential

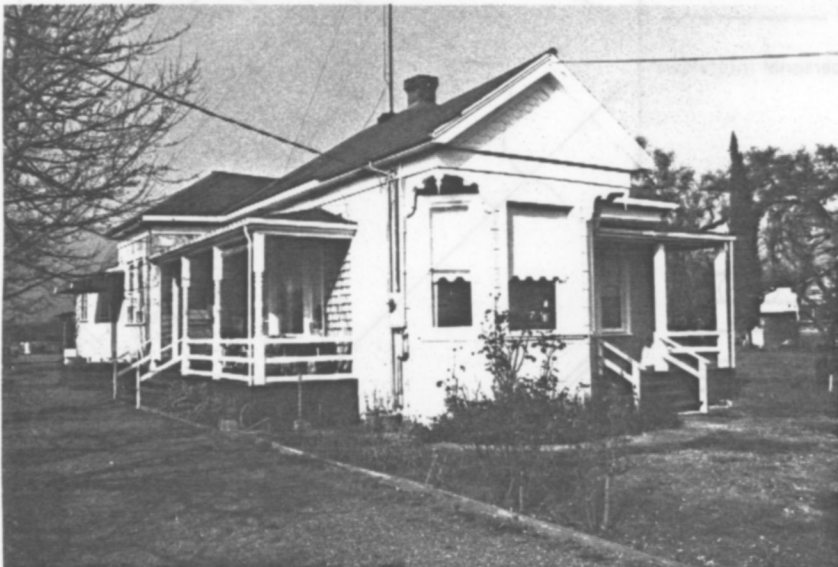
This one-story home has a hip roof with a gabled, front bay. There are additions to the rear. Wood and asbestos shingles hide the original siding. The cornice is boxed and the plain frieze has molding along the top. The windows are double-hung or plate glass, the slanted bay has sawn corner brackets with pendants and cut shingles filling in the closed gable. The front and side porches have hip roofs and plain railings but the side has turned posts and the front posts are square.

13. Condition: Excellent \_\_\_ Good  Fair \_\_\_ Deteriorated \_\_\_ No longer in existence \_\_\_
14. Alterations: Siding, front porch and bay to rear
15. Surroundings: (Check more than one if necessary) Open land  Scattered buildings \_\_\_ Densely built-up \_\_\_  
Residential  Industrial \_\_\_ Commercial  Other: \_\_\_\_\_
16. Threats to site: None known  Private development \_\_\_ Zoning \_\_\_ Vandalism \_\_\_  
Public Works project \_\_\_ Other: \_\_\_\_\_
17. Is the structure: On its original site?  Moved? \_\_\_ Unknown? \_\_\_
18. Related features: \_\_\_\_\_

Despite superficial alterations which mar the integrity of this structure, it retains some Queen Anne detailing.
