HISTORIC RESOURCES INVENTORY

1. Common name: _____
2. Historic name: Boyle House
3. Street or rural address: 614 Johnson Street
City Healdsburg Zip 95448 County Sonoma
4. Parcel number: 002-083-21-0
5. Present Owner: Frashour L. Maude Address: _____
City Petaluma Zip 94952 Ownership is: Public _____ Private X
6. Present Use: residence Original use: residence

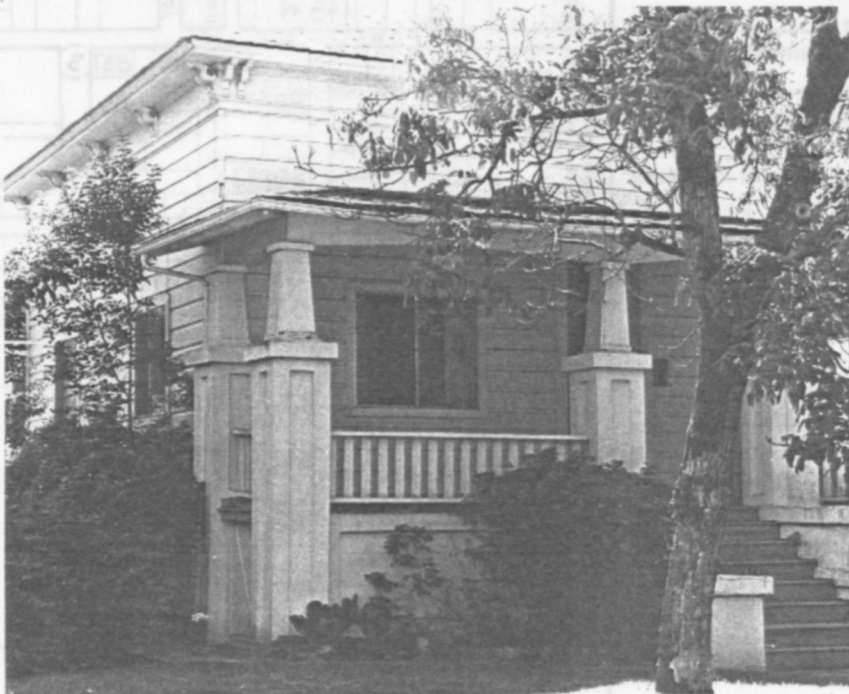
This small hip-roofed cottage has a boxed cornice with paired brackets over a plain frieze. All original windows have been replaced with aluminum windows. The verandah which has been added later in the craftsman style. Short tapered square columns atop stucco pedestal bases support the roof with a flat sawn balustrade system filling in.

13. Condition: Excellent ___ Good X Fair ___ Deteriorated ___ No longer in existence ___
14. Alterations: Aluminum sash front windows, porch addition
15. Surroundings: (Check more than one if necessary) Open land ___ Scattered buildings ___ Densely built-up ___
Residential X Industrial ___ Commercial ___ Other: ___
16. Threats to site: None known X Private development ___ Zoning ___ Vandalism ___
Public Works project ___ Other: ___
17. Is the structure: On its original site? X Moved? ___ Unknown? ___
18. Related features: ___
