HISTORIC RESOURCES INVENTORY

1. Common name: \_\_\_\_\_
2. Historic name: Field Home
3. Street or rural address: 320 Matheson Street  
City Healdsburg, CA Zip 95448 County Sonoma
4. Parcel number: 002-231-08-2
5. Present Owner: Hoag, John W. & Carla Address: 320 Matheson Street  
City Healdsburg, CA Zip 95448 Ownership is: Public \_\_\_\_\_ Private X
6. Present Use: Residential Original use: Residential

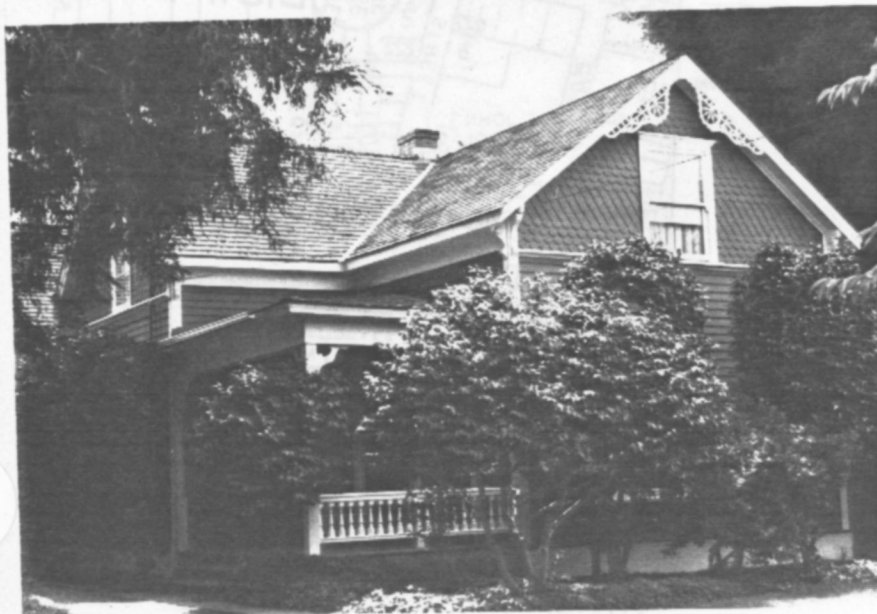
This 1½ story cottage has broad gables filled with cut shingles and double-hung windows. The eaves are closed with sawn brackets at the corners. There is a small rectangular bay set at an angle to corner of the E.W. - N.S. axis of the house. In the opposite corner on the N.E. side is a small porch with turned columns with sawn brackets and a turned balustrade system filling in. The siding is rustic and there are sawn and turned gable braces in the gable ends.

13. Condition: Excellent  Good  Fair  Deteriorated  No longer in existence
14. Alterations: Additions to rear; porch reoriented and rebuilt; iron grillwork removed.
15. Surroundings: (Check more than one if necessary) Open land  Scattered buildings  Densely built-up   
Residential  Industrial  Commercial  Other:
16. Threats to site: None known  Private development  Zoning  Vandalism   
Public Works project  Other:
17. Is the structure: On its original site?  Moved?  Unknown?
18. Related features: Landscaped garden with old large trees
