## HISTORIC RESOURCES INVENTORY

ICATION Common name:	Open land	Commercial	heck more than i industrial	Surreundings: 10 Residential	31
2.	Historic name:Barnes Home	786mgol	Privatà dava	None known,	Threats to site:	31
3.	Street or rural address: <u>427 Matheson</u>	Street		Un us original	1910/02/02 640 2	
	City Healdsburg, CA	Zip	95448	County So	onoma	
4.	Parcel number: 002-201-55-6				2010011	mone
5.	Present Owner: Ossipoff. Lily	sputori) soluța	ioteni lantaani	Address: 427	Matheson	Street
	City Healdsburg, CA	Zip <u>95448</u>	_Ownership is:	Public	Private X	
6.	Present Use: <u>Residential</u>	Orig	inal use: <u>Re</u>	sidential	on fring

- 7a. Architectural style: Queen Anne Cottage
- 7b. Briefly describe the present physical description of the site or structure and describe any major alterations from its original condition:

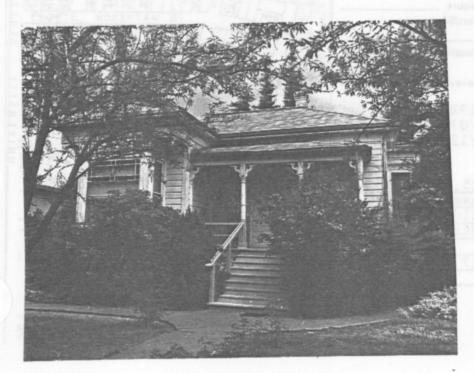
This small one story cottage has a hip and gable roof with a plain boxed cornice. The square bay under the gable has a multi-paned sash with colored glass. The gable is filled with cut shingles and has turned buttons in the frieze below. A small entry porch has turned columns with sawn brackets supporting the hip roof. The open balustrade system is a later replacement. The entry door is recessed in a small paneled vestibule and the siding is channel rustic.

13.	Condition: Excellent Good Fair X Deteriorated No longer in existence
14.	Alterations: None
15.	Surroundings: (Check more than one if necessary) Open land Scattered buildings Densely built-up Residential Industrial Commercial Other:
16.	Threats to site: None knownPrivate development Zoning 021 Vandalism Public Works project Other:
17.	Is the structure: On its original site? <u>yes</u> Moved? Unknown?
18	Related features: _ None
