HISTORIC RESOURCES INVENTORY

1. Common name: _____
2. Historic name: R.A. Petray Property
3. Street or rural address: 11971 Old Redwood Highway
City Healdsburg, CA Zip 95448 County Sonoma
4. Parcel number: 086-120-47
5. Present Owner: Busick, C.J. and Virginia Address: 11971 Old Redwood Hwy.
City Healdsburg, CA Zip 95448 Ownership is: Public _____ Private X
6. Present Use: Residential Original use: Residential

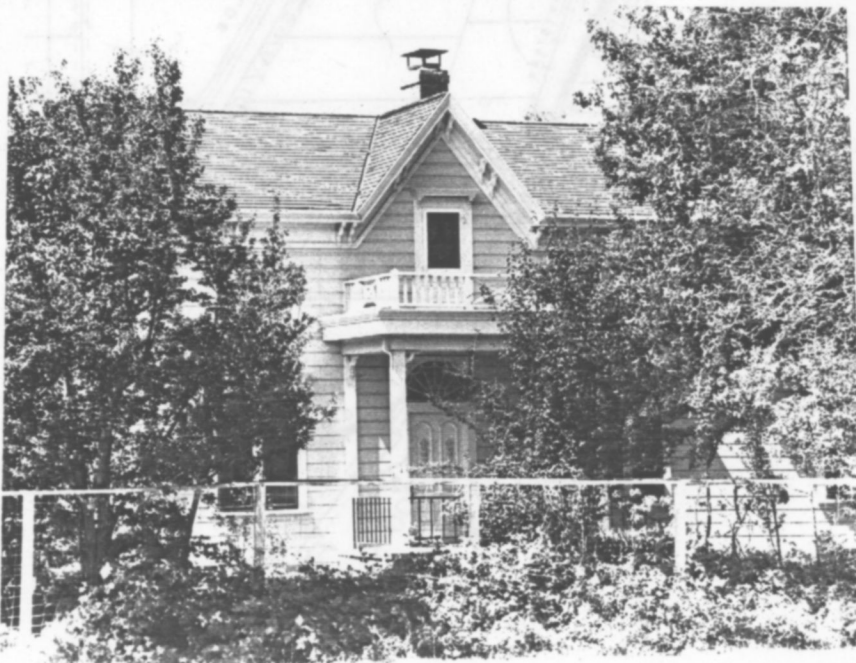
This house is 1½ stories tall with open gable ends and a centered front gable. To one side is a one-story wing which may be original or a very early addition since the detailing is very much like the taller portion of the house. The boxed cornice has a frieze with molding and pairs of sawn brackets. The end gables have bracketed returns. Double-hung windows with semi-elliptical tops are placed in pairs and have molded, bracketed hoods. The doors have similar frames and over the front door is a fan light. A door in the front gable open onto the balustraded roof of the portico which has bracketed square posts and a metal railing (probably a recent addition). The flat roof of the wing has a bracketed, molded cornice but no frieze. It has a wooden balustrade similar to the one atop the portico. The siding is channel rustic. In the rear and adjacent to house is a square tank house with tapering sides and a flat roof.
