HISTORIC RESOURCES INVENTORY

7a. Architectural style: Transitional Bungalow

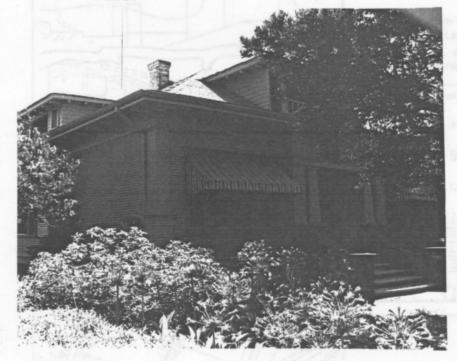
This rectangular one story home has a hip roofed dormer on each side of the main hip roof. The shaped rafter tails are exposed and the siding is narrow rustic. The windows are double-hung or plate glass. Those in groups of three have the panes of the central upper sash and flanking windows in a diamond pattern. The tops of the frames are molded. Tapered posts atop brick pedestals flank the recessed front entrance. Miniature posts and a railing form a small recessed balcony for the front dormer. The front door has beveled glass sidelights. In front of the house is a low wrought iron fence atop a low, cut basalt wall.

Condition: Excellent X GoodFair Deteriors	ated No longer in existence
14.	Alterations: None	NOTAGETHER
15.	Surroundings: (Check more than one if necessary) Open lan Residential Industrial Commercial Other:
