HISTORIC RESOURCES INVENTORY

1. Common name: _____
2. Historic name: _____
3. Street or rural address: 511 Prince Avenue
City Healdsburg Zip 95448 County Sonoma
4. Parcel number: 002-123-15
5. Present Owner: Olivera, Emilia Address: 511 Prince Ave.
City Healdsburg Zip 95448 Ownership is: Public _____ Private X
6. Present Use: Residential Original use: Residential

- 7a. Architectural style: Queen Anne Cottage
- 7b. Briefly describe the present *physical description* of the site or structure and describe any major alterations from its original condition:

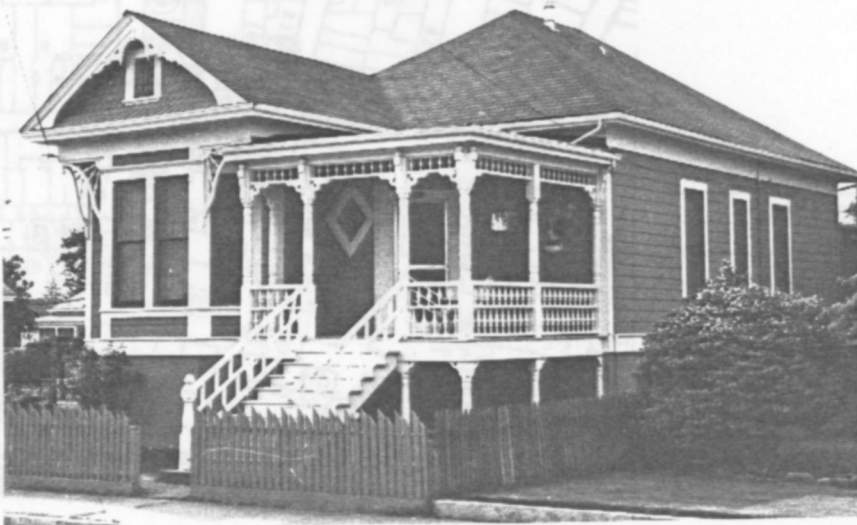
This one story cottage built over a half basement has a hip roof with a gabled front "L". The main cornice is boxed with a plain frieze. The gabled bay is slanted with four double-hung windows with angle brackets composed of turned and sawn elements. The large entry porch supported by turned posts and the roof also has turned columns beneath. The columns are decorated with turned and sawn brackets with turned fretwork filling in. The porch balustrade system consists of two rows of turned ornaments between molded railing. The original stair balustrade has been replaced. The gable has a multi-lite window and is filled in with cut shingles. It is finished with a small barge board and decorative gable brace.

13. Condition: Excellent Good _____ Fair _____ Deteriorated _____ No longer in existence _____
14. Alterations: _____
15. Surroundings: (Check more than one if necessary) Open land _____ Scattered buildings _____ Densely built-up _____
Residential Industrial _____ Commercial _____ Other: _____
16. Threats to site: None known Private development _____ Zoning _____ Vandalism _____
Public Works project _____ Other: _____
17. Is the structure: On its original site? Moved? _____ Unknown? _____
18. Related features: _____
