HISTORIC RESOURCES INVENTORY

- 1. Common name: _____
- 2. Historic name: _____
- 3. Street or rural address: 538 Tucker
City Healdsburg, CA Zip 95448 County Sonoma
- 4. Parcel number: 002-281-08-7
- 5. Present Owner: Lombardi, Loviel & Teresa Address: 538 Tucker
City Healdsburg, CA Zip 95448 Ownership is: Public _____ Private X
- 6. Present Use: Residential Original use: Residential

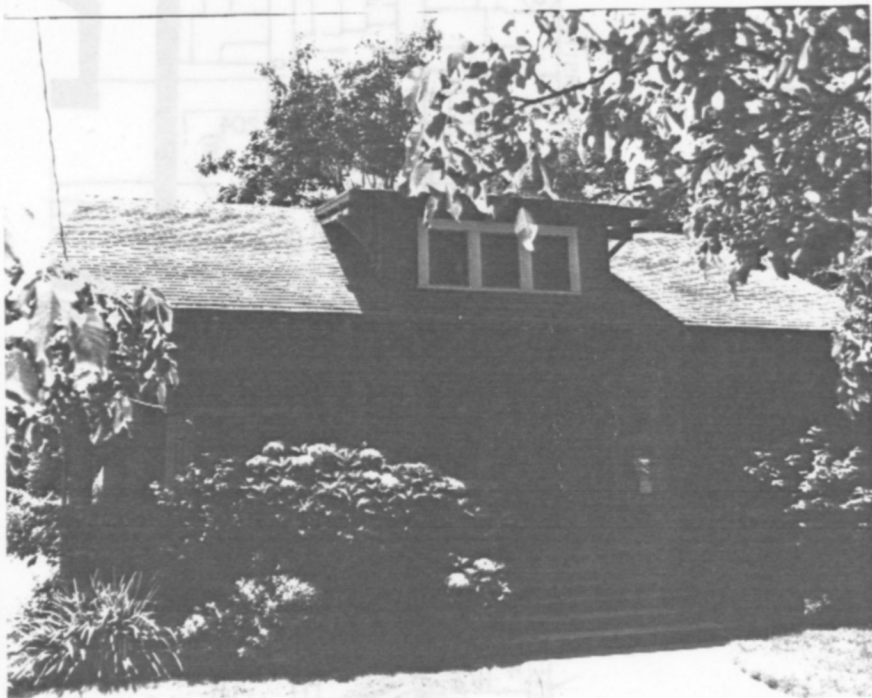
The roof of this single-gable, two-story bungalow covers the recessed verandah and sports a shed-roofed dormer with three windows. Rafter ends are exposed and open brackets support the large rafter. The windows are double-hung and occur singly and in pairs on either side of the front door. This house is covered with wide lap rustic and also forms the verandah balustrade. Pairs of square posts that are designed to look pegged together by a crosspiece support the main beam across the verandah.
