HISTORIC RESOURCES INVENTORY

1. Common name: \_\_\_\_\_
2. Historic name: Bailey Ranch Quarters
3. Street or rural address: 4420 West Sausal Lane  
City Healdsburg, CA Zip 95448 County Sonoma
4. Parcel number: 131-210-28-8
5. Present Owner: Larson, Carter L. Address: 3621 Washington Street  
City San Francisco, CA Zip 94118 Ownership is: Public \_\_\_\_\_ Private X
6. Present Use: Residential Original use: Residential

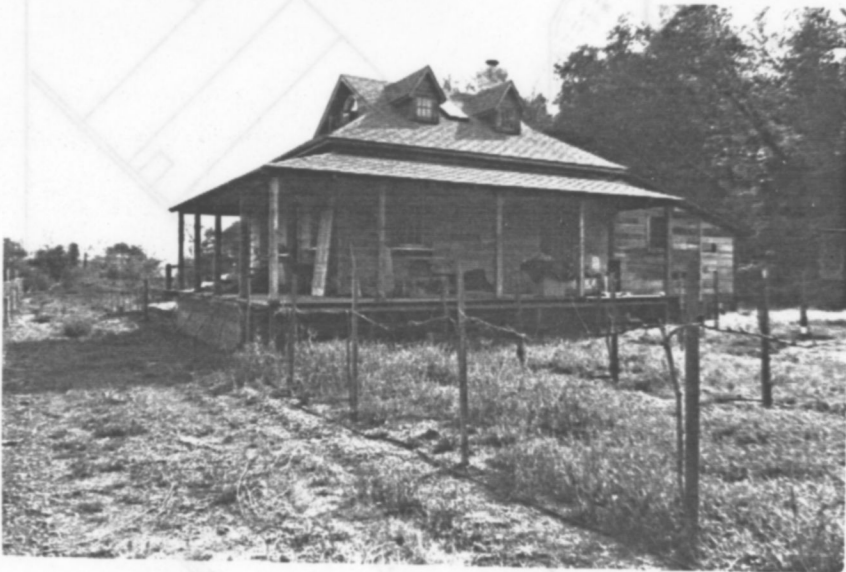
The main section of this house is one-story high with a gable roof and a dormer on each side. Extending from the main structure is a flat roofed porch over a lower level. Cornices on the structure are boxed and the gables have small blocks resembling rafter tails. Windows are double-hung and the exterior is covered with shingles. Shingles also cover the balustrade which has round columns. There are also some large, full-length, round columns. Off one end of the house is a pergola.

13. Condition: Excellent \_\_\_ Good X Fair \_\_\_ Deteriorated \_\_\_ No longer in existence \_\_\_
14. Alterations: Many: front gablet, french doors and balcony, side dormer window
15. Surroundings: (Check more than one if necessary) Open land X Scattered buildings \_\_\_ Densely built-up \_\_\_  
Residential \_\_\_ Industrial \_\_\_ Commercial \_\_\_ Other: \_\_\_
16. Threats to site: None known X Private development \_\_\_ Zoning \_\_\_ Vandalism \_\_\_  
Public Works project \_\_\_ Other: \_\_\_
17. Is the structure: On its original site? X Moved? \_\_\_ Unknown? \_\_\_
18. Related features: Vineyard
