## HISTORIC RESOURCES INVENTORY

DENTIF	ICATION	Hop V	ila Uin					ALGERTONE: THE	.01
1.	Common name: _	порк	TIH WIH	ery		THE BOTO THE BOTO	OF IT AUDIES	d segmented type	701
2.	Historic name:	None		Other:	- Isipren	alCom	rumbol_	Residential	
3.	Street or rural add	ress: 60	50 West	side Roa	d	rii mwonii	впоИ	:87ig 01 Edecut?	.81
	City Heald	sburg,	CA	Zip_	95448	County_	Sonor	na	
4.	Parcel number:	110-16	0-02-5						
5.	Present Owner: _	Griffi	th, Mar	tin Jr.		Address:	6050	Westside	Road
	City Heal	dsburg.	CA	Zip 9544	8_Ownershi	p is: Public _	ns Isono)	PrivateX	,81
6.	Present Use: C	ommerci	al	o	riginal use:	Unknown	1	noma Cour	(8)

7a. Architectural style: Italianate

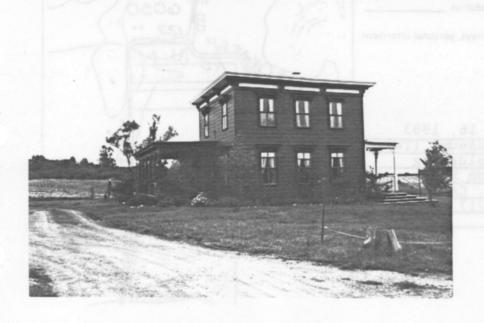
12. Date(s) of enclosed photograph(s) 22 Apr 83 48/30

A two-story, boxed shaped Italianate with a flat roof. The boxed cornice has a molded fascia board. The panelled frieze has four molded brackets on each side of the structure. Windows are double-hung with each sash having two panes. The windows are symmetrically placed with those of the upper story being directly above those on the first. Each window has a bracketed, molded hood. All of the siding is channel rustic. There are flat roofed porches in the front and back which are not quite identical though both have square posts, sawn brackets, and railings with simple balustrades.
